EVALUATION OF BERYLLIUM, TOTAL CHROMIUM AND NICKEL IN THE SURFACE
CONTAMINANT LAYER AVAILABLE FOR DERMAL EXPOSURE AFTER ABRASIVE
BLASTING IN A SHIPYARD

Thesis submitted to the Faculty of the
Preventive Medicine and Biometrics Graduate Program
Uniformed Services University of the Health Sciences
In partial fulfillment of the requirements for the degree of
Masters of Science in Public Health 2013

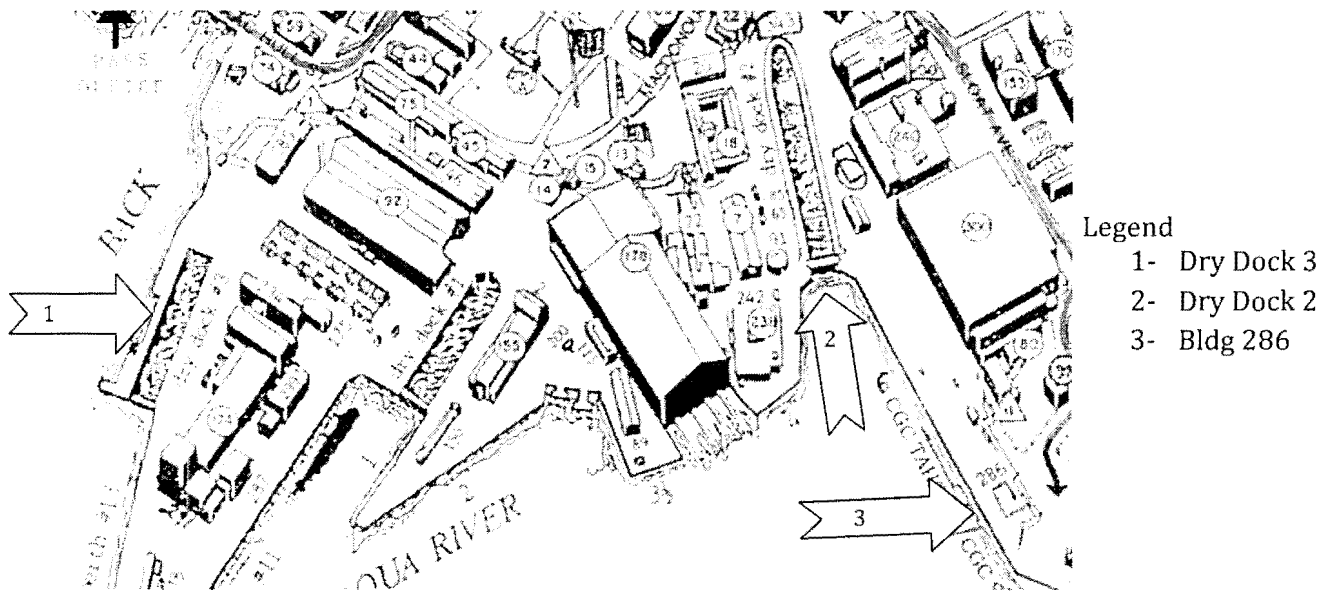
Figure 1: Map of Portsmouth Naval Shipyard with air and wipe sampling locations identified

Repainting consists of three steps, first abrasive blasting, then cleaning, followed by repainting of the original surface. During blasting, many abrasives such as garnet shot and steel shot are used, but where beryllium was identified in the breathing zone air samples at Portsmouth NSY, coal slag was the abrasive in use. Within Portsmouth NSY, there are two main areas where coal slag is used for blasting: the dry docks for blasting of submarines and in Building 286. Building 286 is a large bay room building where submarine shafts and rudders and other large components are brought for specific blasting. See Figure 1 for locations.

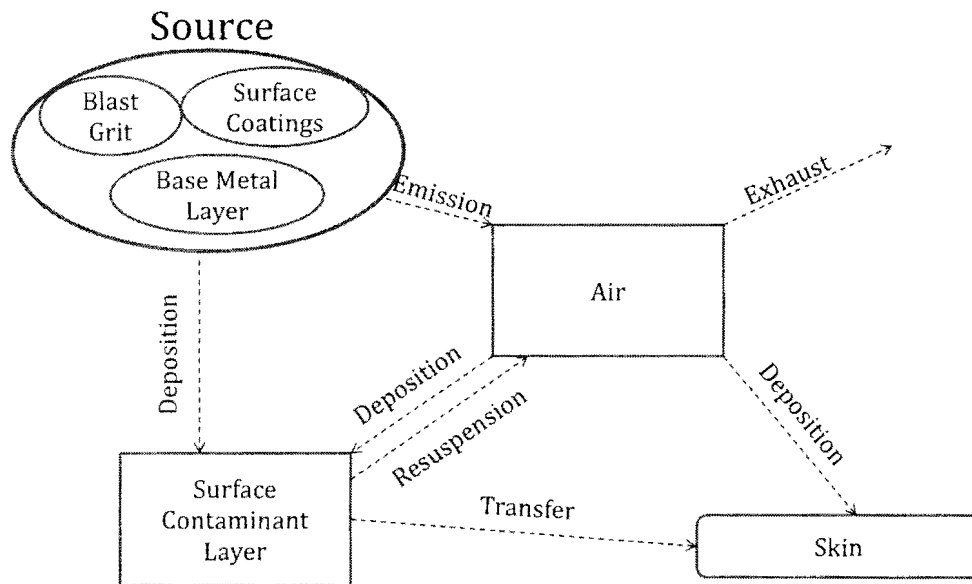
Figure 2: Conceptual model for dermal exposure used for comparison exposed and non-exposed surface contaminant layer study. Source is combination of blast grit, surface coatings and base metal layer.

in the conceptual model in Figure 2. This increase in potential exposure requires that cleaning of the equipment be conducted and personal protective equipment be worn to prevent exposure to skin, in both Building 286 and on the submarines.

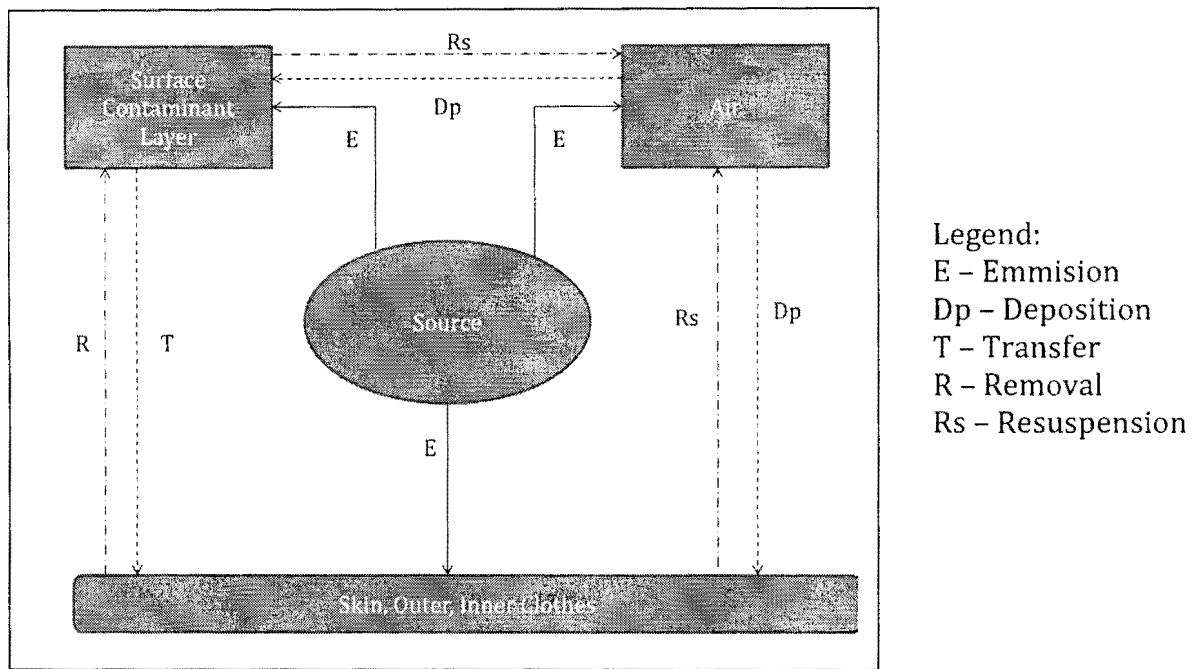
Figure 3: Conceptual model for dermal exposure
(Schneider et al., 1999)

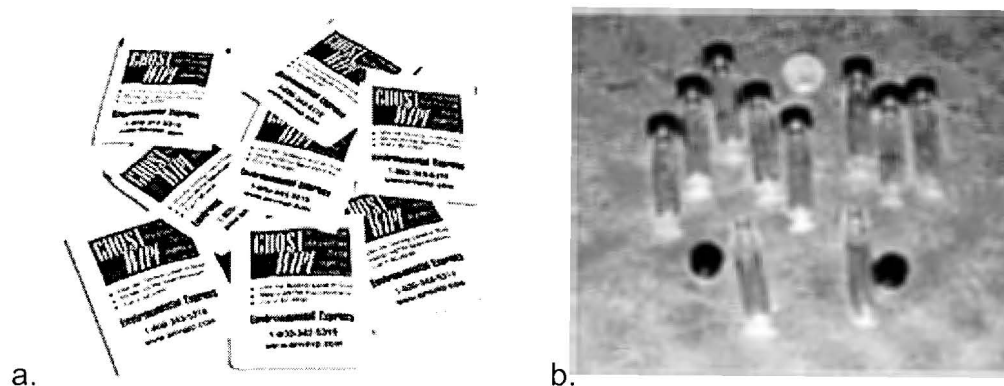
Figure 4: Examples of supplies used for wipe sampling
a) Ghost Wipes for collecting dust from surface contaminant layer
and b) Glass Shipping Vials to send samples to laboratory

The method used for surface contaminant layer wipe sampling was OSHA ID-125G. The materials used by this method were ghost wipes; 100 cm² templates to outline the sample area; and sample vials/ bags to submit the samples for inductively coupled plasma mass spectrometry analysis. Figure 4 shows examples of the ghost wipes and the glass vials. The ghost wipes were manufactured by Environmental Express and are pre-moistened with deionized water packaged in individually sealed packets. When analyzed

at the lab, the ghost wipes completely dissolve in solution allowing for total analysis of dust from the wipe (17). The templates were ordered from SKC Corp. For shipping the collected samples to the laboratory, glass vials were used until supply was exhausted, then plastic Ziploc® bags were used.

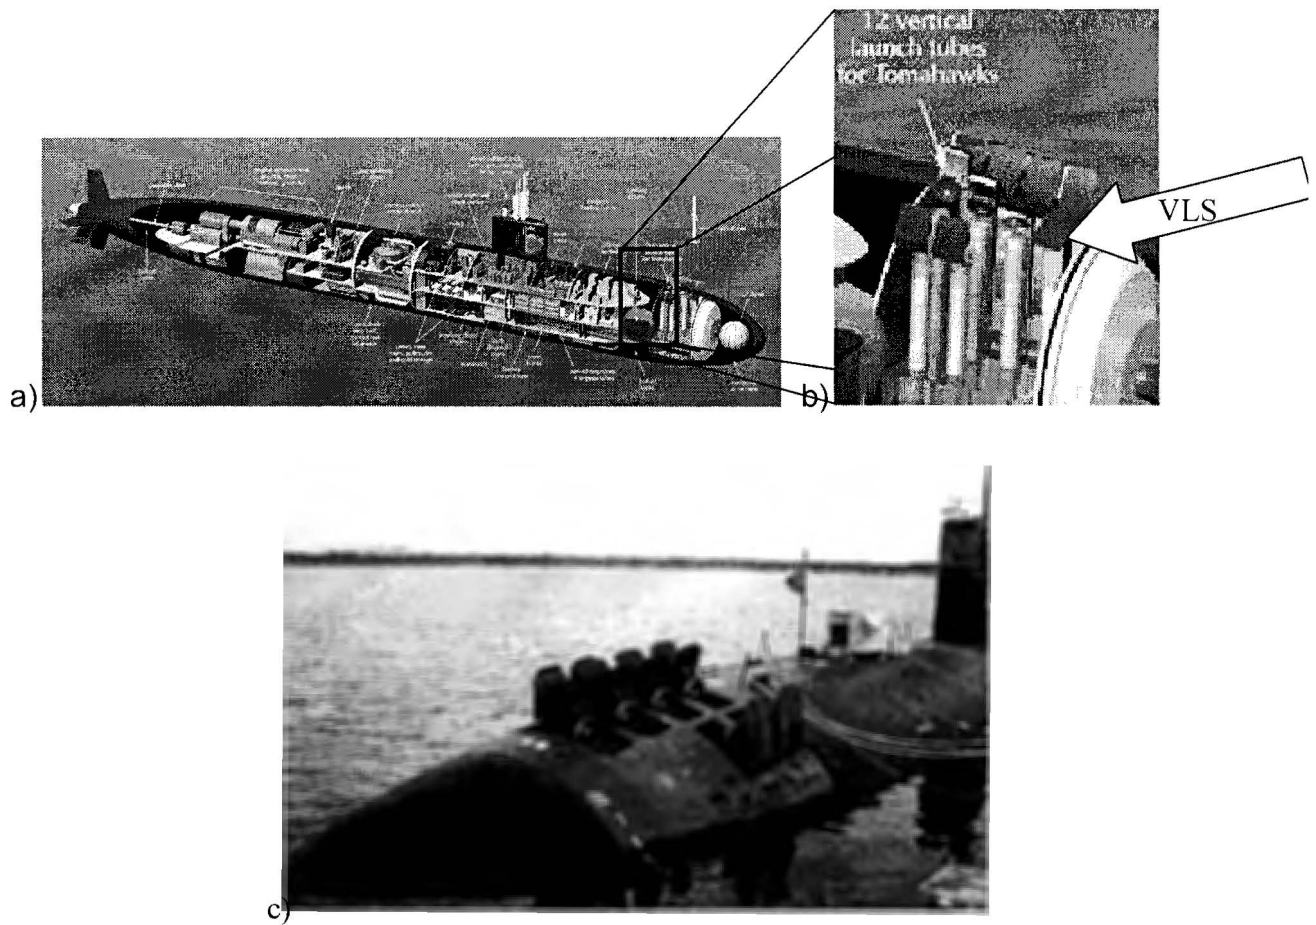
Figure 5: Los Angeles Class Submarine

a) Cut away of Los Angeles Class Submarine and b) close up of Vertical Launch System, with c) photo of VLS open, which is the exposed area on the submarines where wipe

The submarines sampled were the USS MIAMI (SSN 755) and the USS PASADENA (SSN 752). At the time of the study, these were the two submarines that were present for repair and maintenance services. The exposed areas were limited to the vertical launch system (VLS) areas at the bow of the USS MIAMI and the cap stand area on the USS PASADENA, both Los Angeles class submarines, and the large abrasive blast building (Bldg 286). The cap stand is between the VLS and the sail of the submarine. Figure 5 shows the location of the exposed areas on the submarines. The three exposed sampling areas were distinct and did not have influence on each other; Figure 1 shows the locations of the sampling areas. The USS PASADENA was in dry dock 1 and the USS MIAMI was in dry dock 2.

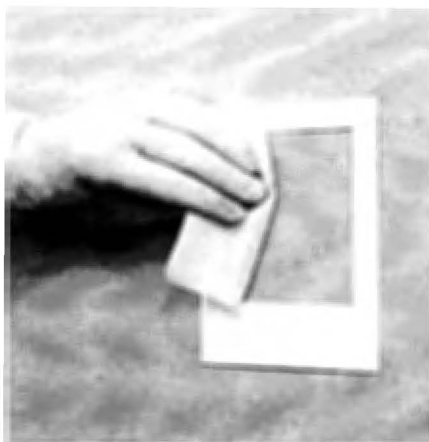
Figure 6: Example of Wipe Sampling Procedure

The procedure used for sampling was the single wipe sample technique outlined in Navy Industrial Hygiene Field Operations Manual NEHC-TM6290.91-2 Rev. B, Chapter 3 Section 17, 3, i. This specified that OSHA method ID-125G be used to conduct the wipe sampling(37). To prevent sample contamination, each individual wipe sample was taken when clean gloves were donned.

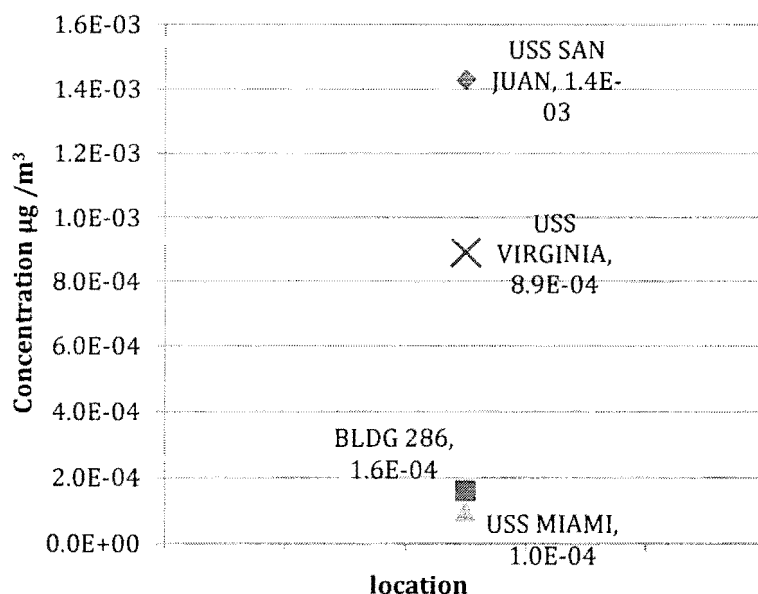
Figure 7: Median beryllium air sample by work place location
with below LOD results reported as equal to LOD
divided by 2

There were 33 air samples analyzed for beryllium from the four work areas, 18 from Building 286, 8 from the USS SAN JUAN, 4 from the USS MIAMI, and 3 from the USS VIRGINIA. The median concentrations for beryllium in the air are displayed in figure 7 and listed in table 2 with a range from $3.0 \times 10^{-5} \mu\text{g}/\text{m}^3$ to $2.04 \times 10^{-3} \mu\text{g}/\text{m}^3$. Median values are used to minimize the impacts of the outliers. Detectable amounts of beryllium were observed in 12 of the 33 samples, 10 detectable samples were taken aboard submarines and 2 were taken in Building 286. Factoring out samples with results falling below LOD, the range of detectable samples was from $6.5 \times 10^{-4} \mu\text{g}/\text{m}^3$ to $2.04 \times 10^{-3} \mu\text{g}/\text{m}^3$. Detailed results are provided in Appendix 3.

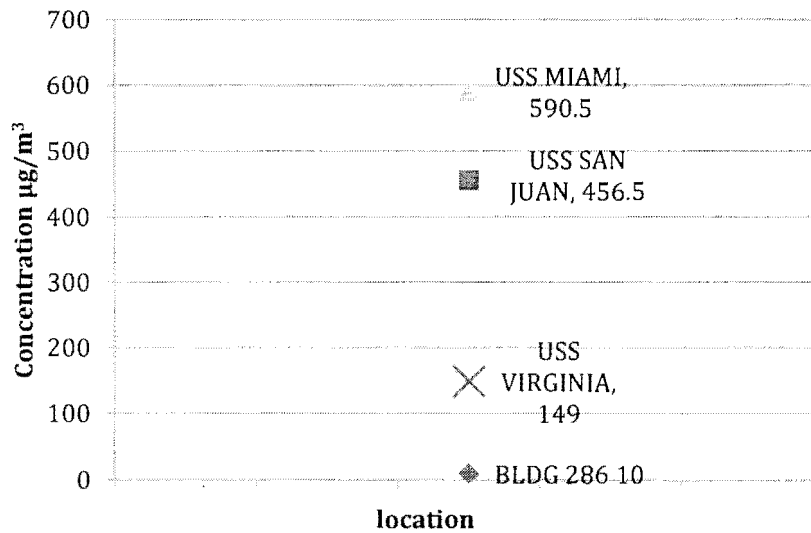
Figure 8: Median total chromium air sample by work place location with below LOD results reported as equal to LOD divided by 2

submarines. From Building 286, 13 samples were analyzed of which 3 were below LOD. The submarines had a total of 15 samples analyzed all of which were above LOD. The total chromium results found above the LOD demonstrate that there is a potential for this metal to be present in these work areas. Detailed results are provided in Appendix 2.

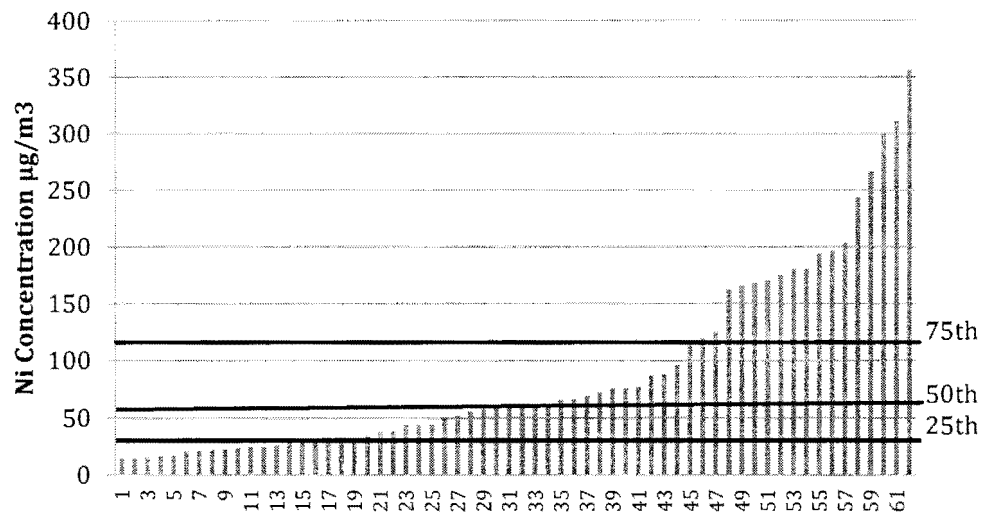
Figure 9: Exposed work area nickel wipe sample above LOD result distribution with 25th, 50th and 75 quartiles.

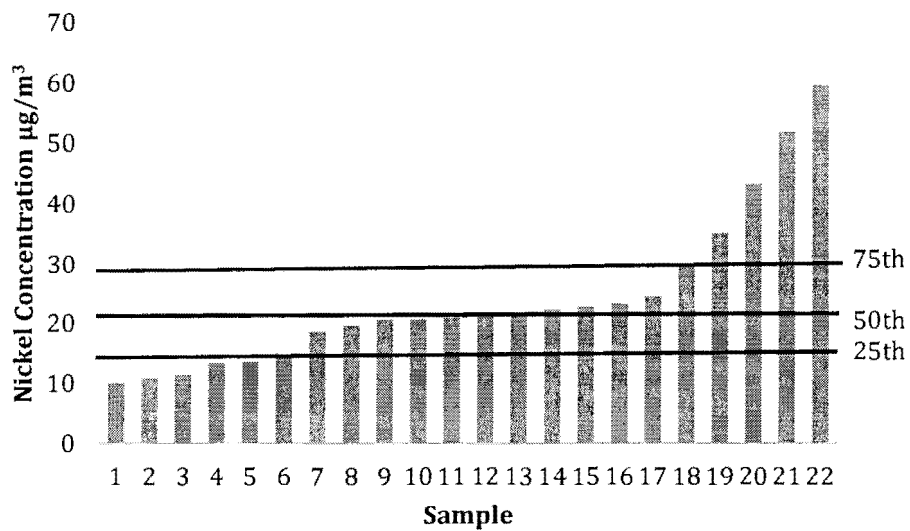
Figure 10: Non-exposed work area nickel wipe sample above LOD result distribution with 25th, 50th and 75th quartiles.

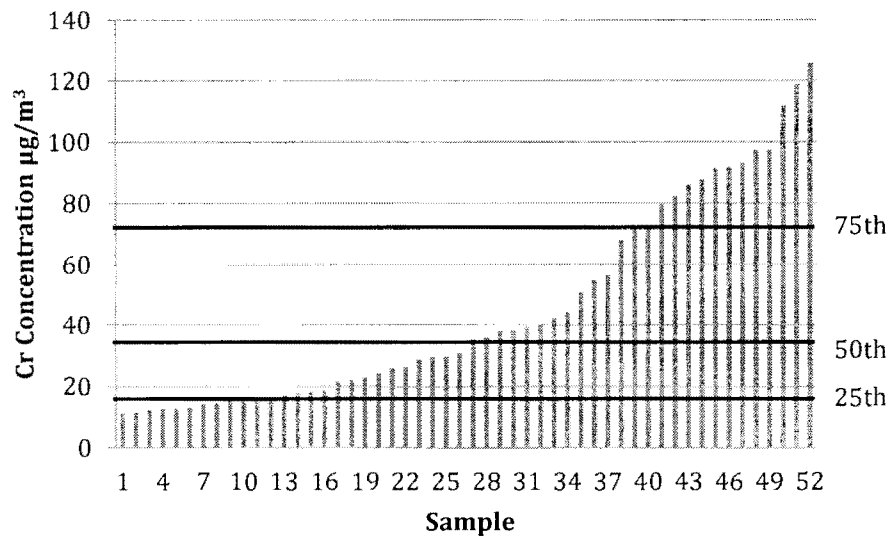
Figure 11: Exposed work area total chromium wipe sample above LOD result distribution with 25th, 50th and 75th quartiles.

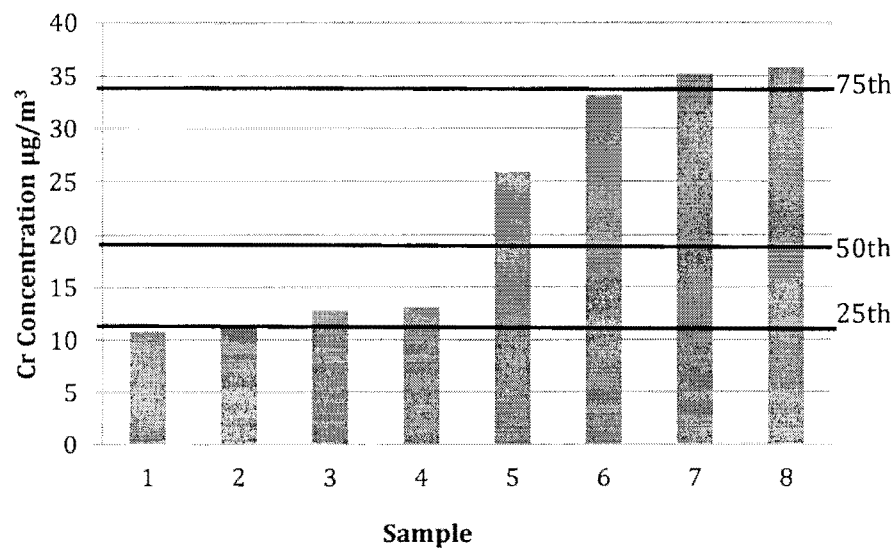
Figure 12: Non-exposed work area total chromium wipe sample above LOD result distribution with 25th, 50th and 75th quartiles.

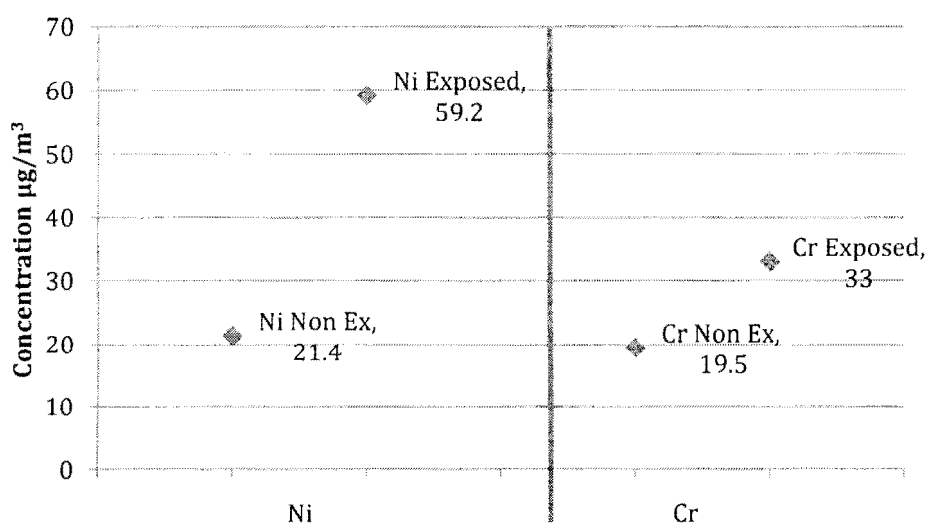
Figure 13: Total chromium and nickel median wipe sample results for exposed and non-exposed work areas

The nickel and total chromium exposed samples were compared to the non-exposed samples using the Mann Whitney U test. This comparison determined that there were statistical differences between the exposed and non-exposed samples for both nickel and total chromium, with significance levels below 0.001 for both metals, as seen in table 5. Figure 13 shows the median sample results for each group. One non-exposed sample had high levels of nickel, this sample remained in the group analysis that is displayed in Figure 13. This sample was from a table top in the lower level of a support structure for the USS PASADENA that was coated with dust. The Mann Whitney U comparison test was repeated with this outlier removed and the test still determined that there was a statistical difference with the significance level below 0.05.

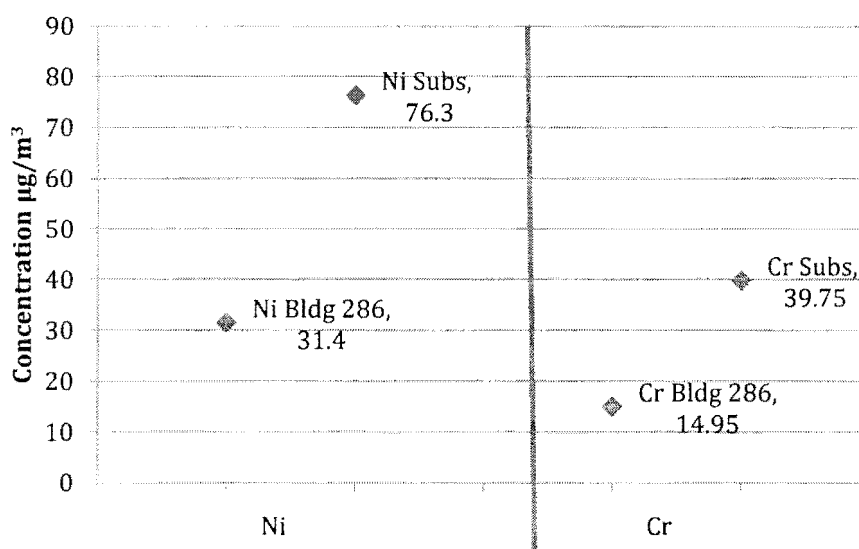
Figure 14: Total chromium and nickel median wipe sample results for exposed work area in Building 286 and on combined submarines

To complete aim #2 the exposed samples from the combined submarines were compared to the exposed samples from Building 286. Using the Man Whitney U test, a statistical difference was found between samples with a significance level below 0.001. This demonstrates that there was a greater amount of nickel and chromium aboard the submarine exposed samples than the Building 286 exposed samples as shown in Figure 14, which displays the median sample results for each group.

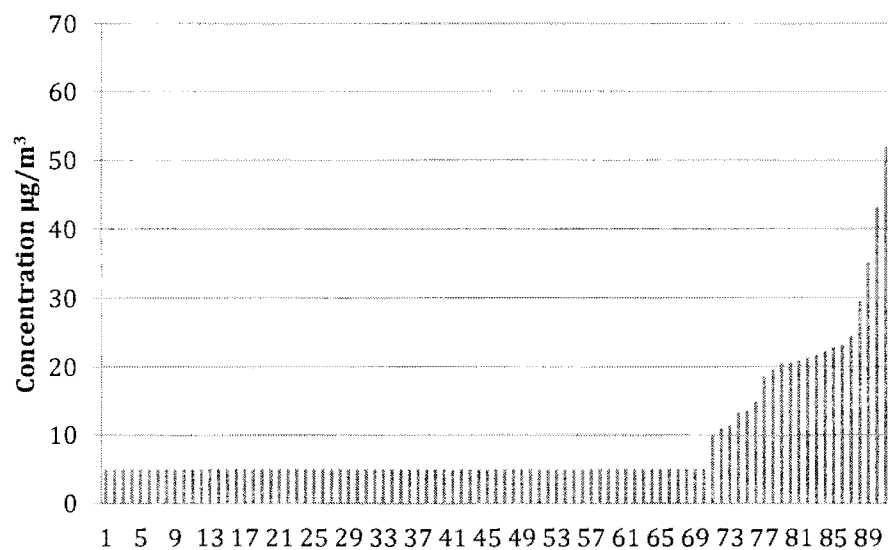
Figure 16: Non-exposed work area nickel wipe sample result distribution with below LOD results and without outlier

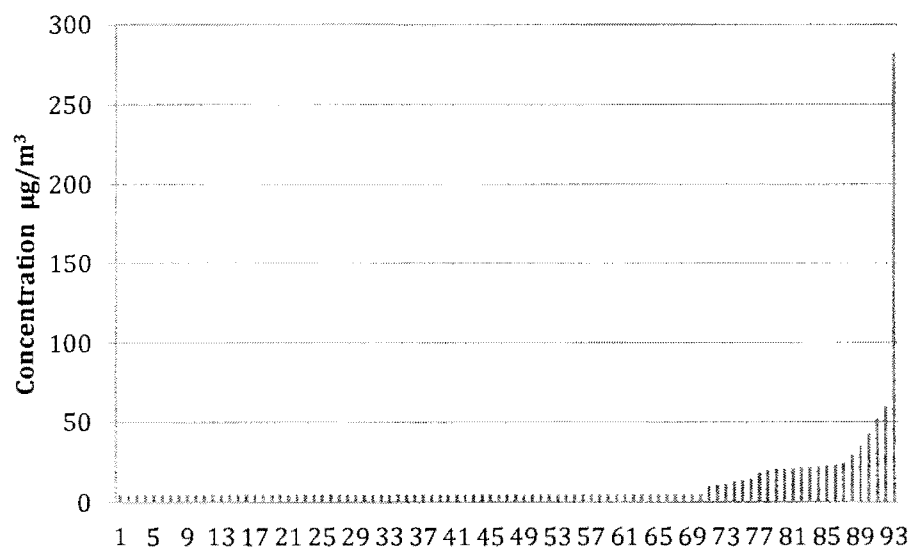
Figure 17: Non-exposed work area nickel wipe sample result distribution with below LOD results and with outlier

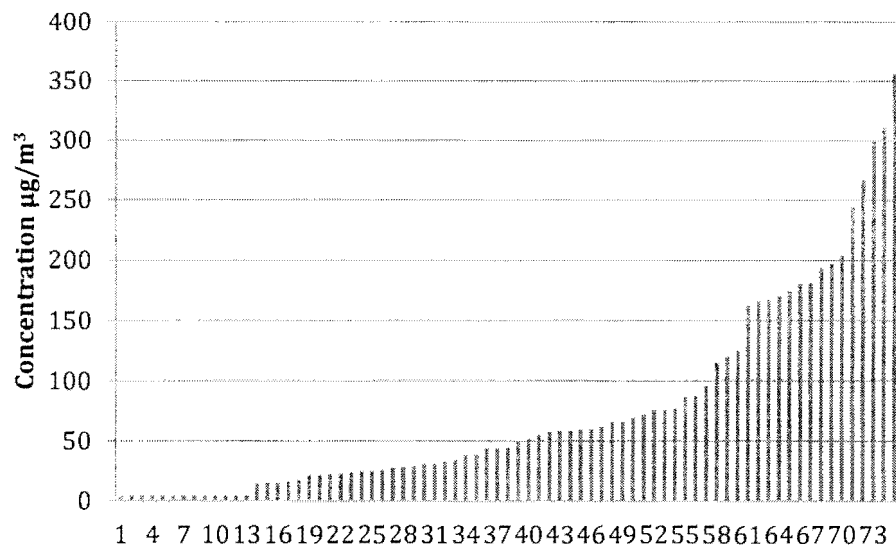
Figure 18: Exposed work area nickel wipe sample result distribution with below LOD results

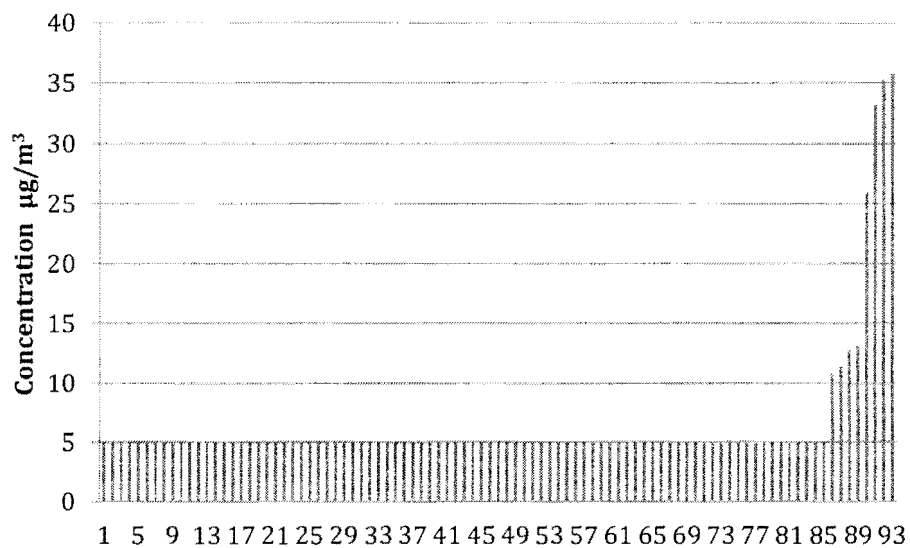
Figure 19: Non-exposed work area total chromium wipe sample result distribution with below LOD results

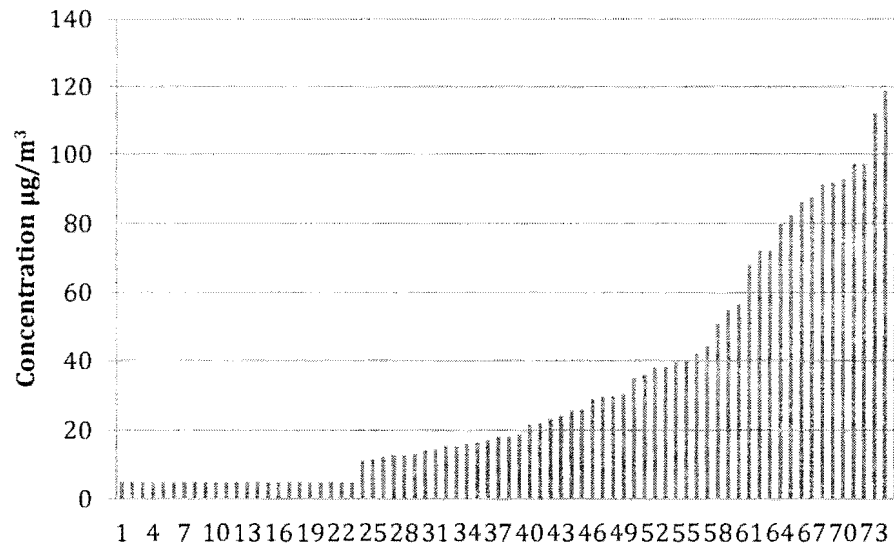
Figure 20: Exposed work area total chromium wipe sample result distribution with below LOD results
